**Flood Control Project Maintenance
Levee Inspections**

Fall 2009 Levee Maintenance Deficiency Summary Report

Reclamation District No. 2063 Crows Landing

Levee Inspection Report By Mile - Fall 2009

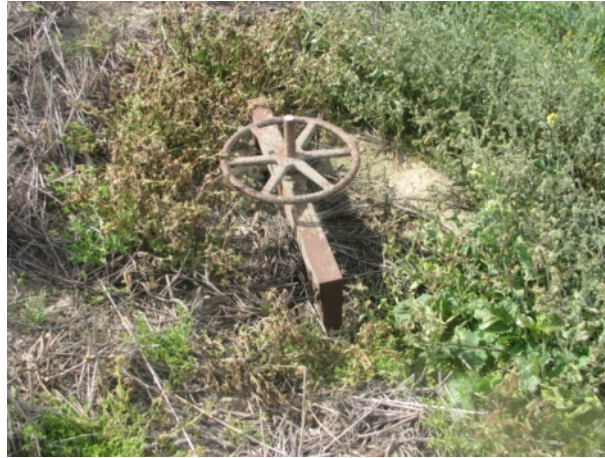
Levee Mile Report Line	9
Start Levee Mile	1.92
End Levee Mile	1.92
Location	Water Side
Category	Interior Drainage & Piping Systems
Item	Sluice / Slide Gates
Screw gate buried on landside slope at LM 1.92	
richard_20091104_79.jpg

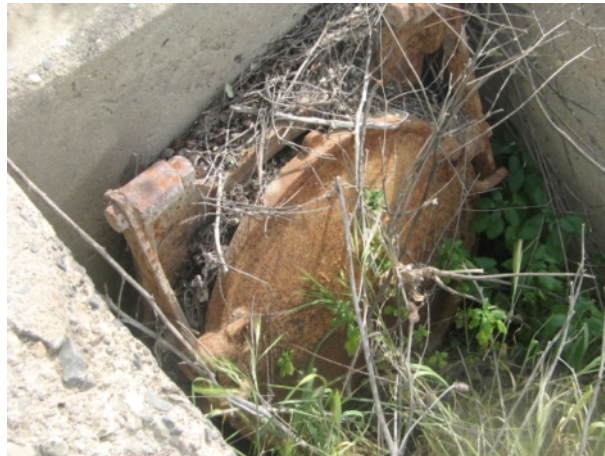
Levee Mile Report Line	14
Start Levee Mile	2.66
End Levee Mile	2.66
Location	Water Side
Category	Interior Drainage & Piping Systems
Item	Flap Gates
Flap gate blocked at LM 2.66	
richard_20091104_80.jpg

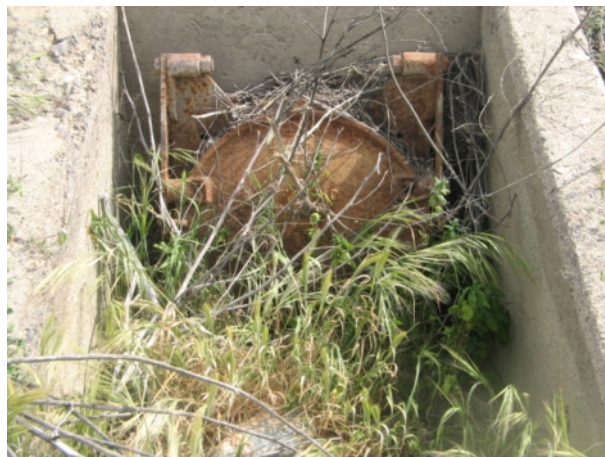
Levee Mile Report Line	14
Start Levee Mile	2.66
End Levee Mile	2.66
Location	Water Side
Category	Interior Drainage & Piping Systems
Item	Flap Gates
Front view of blocked flap gate at LM 2.62	
richard_20091104_81.jpg

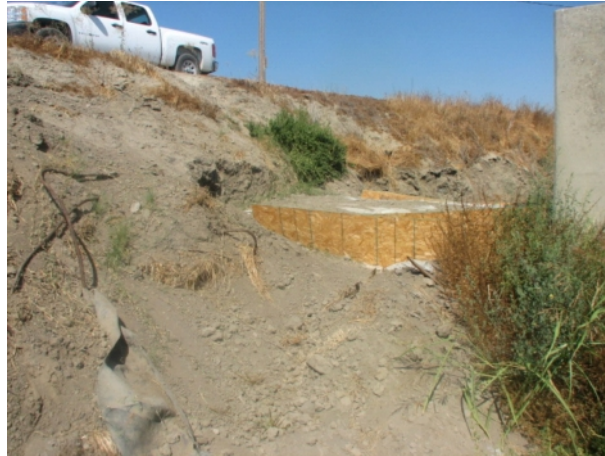
Levee Mile Report Line	27
Start Levee Mile	5.13
End Levee Mile	5.13
Location	Land Side
Category	Earthen Levee
Item	Encroachments

27	5.13	5.13	Earthen Levee	Encroachments	LS	U	Pipe Inspector Comments: Landowner modify pipe structure and cut into landside slope without permission from CVFPB. See field investigation report for more detail.	37.427210 ° -120.999288 °	37.477210 ° -120.992880 °	50 Y
28	6.03	6.19	Earthen Levee	Vegetation	LS	M	Remove the wild growth other than native grasses from the levee slopes.	37.416498 ° -120.997435 °	37.415155 ° -120.999809 °	38
29	6.04	6.08	Earthen Levee	Vegetation	WS	C	Remove the wild growth other than native grasses from the levee slopes.	37.416308 ° -120.997531 °	37.415877 ° -120.998125 °	37
30	6.89	6.89	Earthen Levee	Trim / Thin Trees	LS	M	Trim trees to at least five feet above ground level.	37.411785 ° -120.993548 °	37.411785 ° -120.993548 °	39
31	7.08	7.08	Earthen Levee	Slope Stability	LS	C	Repair slope instability.	37.409112 ° -120.992027 °	37.409112 ° -120.992027 °	40
32	8.71	8.76	Earthen Levee	Encroachments	LS	C	Agricultural tilling	37.396642 ° -120.971443 °	37.396086 ° -120.971029 °	974

View of cut into landside slope

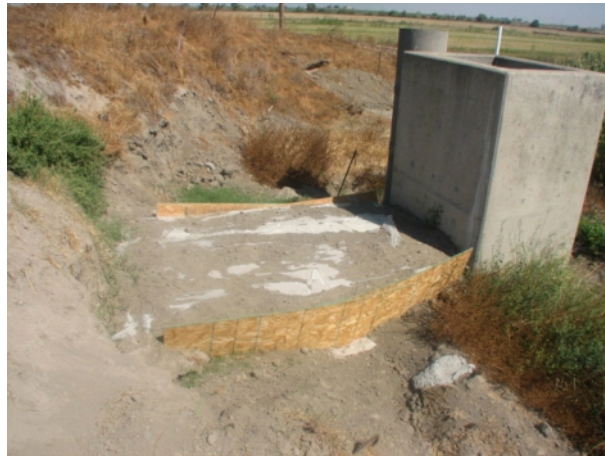
Levee Mile Report Line	27
Start Levee Mile	5.13
End Levee Mile	5.13
Location	Land Side
Category	Earthen Levee
Item	Encroachments

View of concrete stand pipe and encased pipe on landside toe.
